Title: **PRELIMINARY DESIGN STAGE QUALITY AUDIT**  
**For;**  
**Leydens Wholesalers & Distributors Dublin, No. 158A**  
**Richmond Road**

Client: **DBFL Consulting Engineers**

Date: **February 2023**

Report reference: **1754R01**

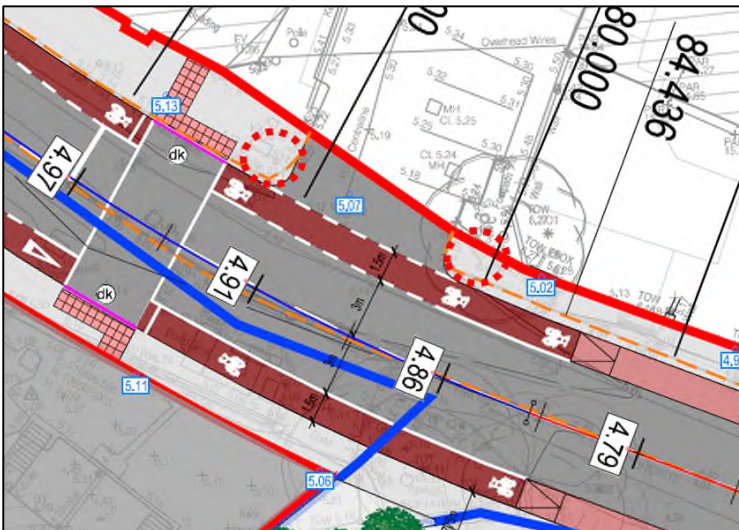
### Problem S1 – No Tactile Paving at uncontrolled crossing

It is proposed to provide a signalised pedestrian crossing to bring pedestrians across Richmond Avenue to the continuous footpath on the northern side. There is however no tactile paving and only partially dropped kerbs at the crossing at the mouth of Waterfall Avenue. This could lead to blind or partially sighted pedestrians not realising that there is a hazard ahead and they may inadvertently stray into the Richmond Road carriageway where they would be at greater risk of being struck by a passing vehicle.

#### Recommendation:

<b>S1</b>	Yes	Yes		
<b>S2</b>	Yes	Yes		
<b>S3</b>	Yes	No	The scheme presented in the submitted development proposals is an interim tie-in (between existing street alignment and improvement works by applicant across its site frontage) until such time that DCC implements its works as part of the Richmond Road corridor enhancements. This existing footpath at its narrowest section is 1.3m wide. Due to third party boundary constraints to the north AND south of the Richmond Rd corridor it has not been possible for the applicant to widen this specific off-site section of the northern footpath without narrowing the southern footpath to less than the 2.0m wide (at this narrowest point at Deakin Court). The southern footpath experiences the larger number of pedestrian traffic in addition to it leading to a new active travel connection to/from the proposed Tolka River Greenway (along the eastern boundary of Deakin Court as part of a separate SHD application on the adjoining Phase 1 plot). It is subsequently considered a greater priority to retain the 2m width at the southern footpaths pinch point (adjoining position of	<b>Yes</b>

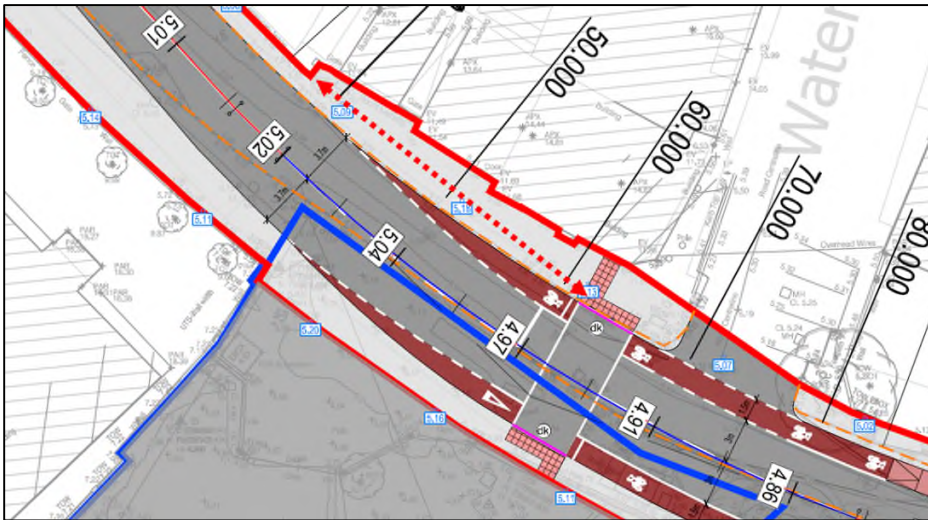
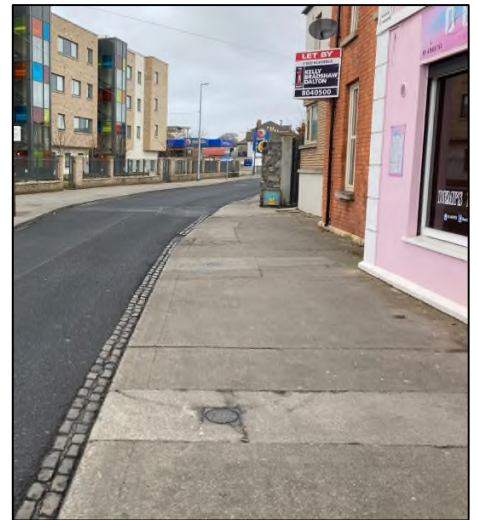
### Problem S2 – Visibility at Signalised Pedestrian Crossing

Visibility to the right for pedestrians wishing to cross Richmond Road at the proposed signalised crossing location is limited by a built out wall. Eastbound vehicle speed were observed to be relatively high at the time of the site visit. A lack of inter-visibility between pedestrians and vehicle drivers could lead to collisions.

#### Recommendation:

It is recommended that traffic calming measures be provided on Richmond Road to ensure slow traffic speeds. A raised crossing may be one such measure.

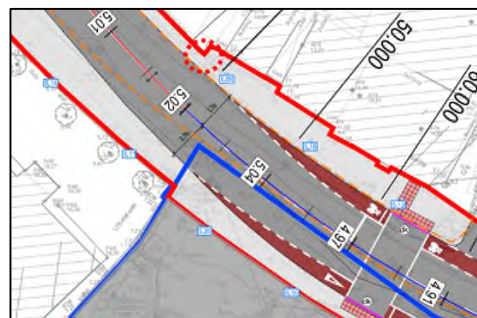
### Problem S3 – Insufficient width of Proposed Footpath

The width of the proposed footpath at the pinch north of the proposed signalised crossing appears quite tight. There were no legible dimensions for auditors to decipher the minimum width proposed. If the footpath width is less than 1.8m, it could lead to pedestrians experiencing difficulty when two people pass each other, particularly for wheelchair users and with buggies.

#### Recommendation:

The designers should ensure that an appropriate footway width in accordance with (i) the requirements of DMURS and (ii) the anticipate pedestrian volumes is provided.

To be Completed By Designer				To be Completed by Audit Team Leader
			proposed active travel link to Tolka Greenway) than in the short term increase the width of the 1.3m wide northern footpath. The northern footpath will be widened at the time when the local authority is advancing its own proposals (identified as a specific roads objective in the DCC Development Plan) for the Richmond Road enhancement works beyond that being delivered by the subject development proposals. The local authority will be made away of the auditors concerns thereby informing the design of the Richmond Road enhancement works being delivered by DCC in the future.	
<b>S4</b>	Yes	Yes		
<b>S5</b>	Yes	No	The internal ground floor level of proposed development is being designed at a higher level to the existing road carriageway in part in response to long term flooding events of the adjoining Tolka River. Whilst pedestrian steps are proposed to the west of the Block A entrance / exit point an alternative route incorporating a ramp of appropriate gradient and width is provided to the east of the buildings entrance / exit point to accommodate the access requirements of mobility impaired users. The replacement of the proposed steps with a second ramp treatment is not possible without adversely impacting upon the width of the 'public' footpath which is to be adopted and managed by the local authority.	<b>Yes</b>

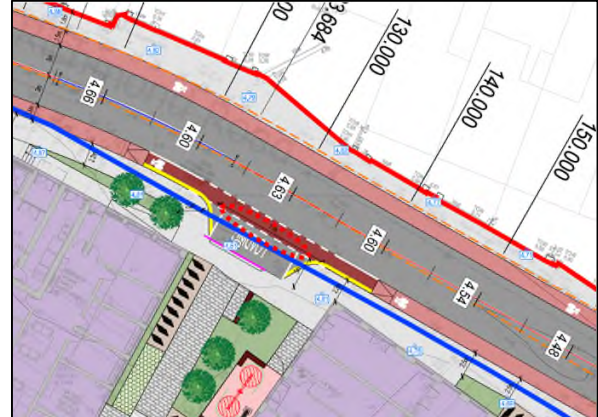
#### Problem S4 – No buffer between the loading bay and the cycle lane

A buffer has not been provided between the loading and the northbound cycle lane. The auditors have concerns that loading vehicle operators may open their door to on-coming cyclists, resulting in potential serious injuries.

##### Recommendation:

The auditors recommend a buffer is provided between the loading bay and the northbound cycle lane. This buffer may be provided by road markings, which should encourage suitable kerbside loading while providing sufficient distance between the loading bay and the cycle lane.

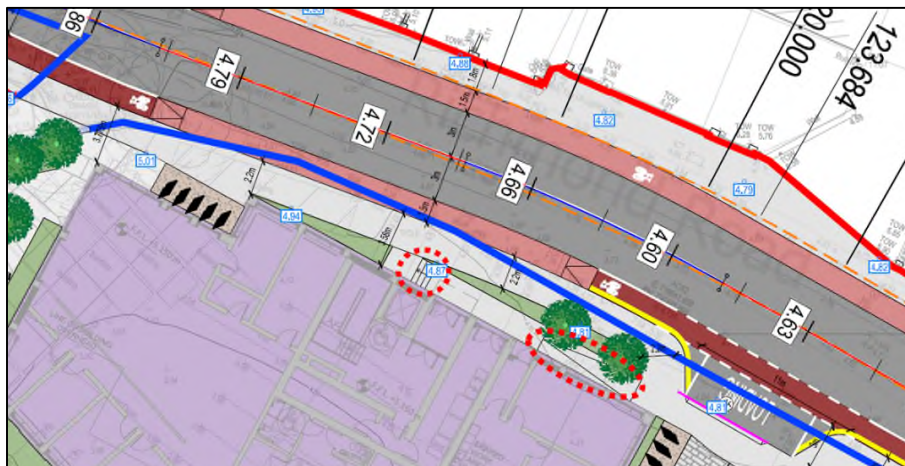
#### Problem S5 – Steps on pedestrian links

It is unclear to the auditors what the proposed levels for the pedestrian links to the proposed development are to be. It appears that steps are proposed at a pedestrian access to the development, which may limit its use by mobility impaired users. Mobility impaired users may have a longer journey to reach their homes depending on their origin.

##### Recommendation:

It is recommended that pedestrian links without steps be provided throughout the scheme to cater for all users (particularly mobility impaired users).

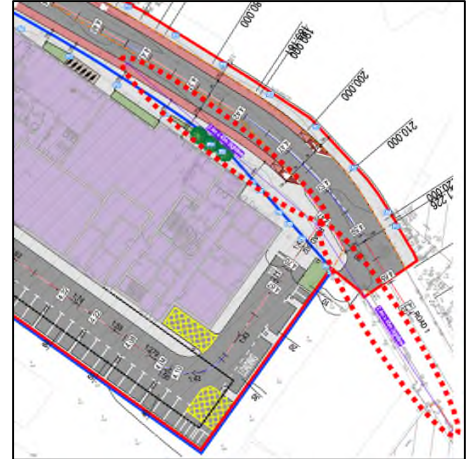
**Problem S6 – Site access visibility splay.**

The auditors note that visibility splays have been provided for a 50kph road with no bus routes, as per DMURS guidance. The auditors have concerns that if future bus routes are provided on Richmond Road that sufficient visibility splay will not be achievable and may result in vehicular collisions.

**Recommendation:**

It is recommended visibility splays for a 50kph Road with bus routes, as per DMURS guidance, are provided to future proof the proposed site access.

<b>S6</b>	Yes	Yes	Visibility Splays of 49m as per DMURS guidance can be provided to approaching vehicles should buses be rerouted along the Richmond Road corridor sometime in the future.	
<b>S7</b>	Yes	Yes		
<b>S8</b>	Yes	Yes	The existing macadam surfacing treatment is to be replaced with a raised reinforced concrete footpath (with bevel edge) which affords priority to pedestrians and required vehicle drivers to yield to vulnerable road users. In the context of the modest volume of vehicle movements traveling to/from this small business park and overriding policy context to prioritise active travel uses this approach is considered a safer design solution.

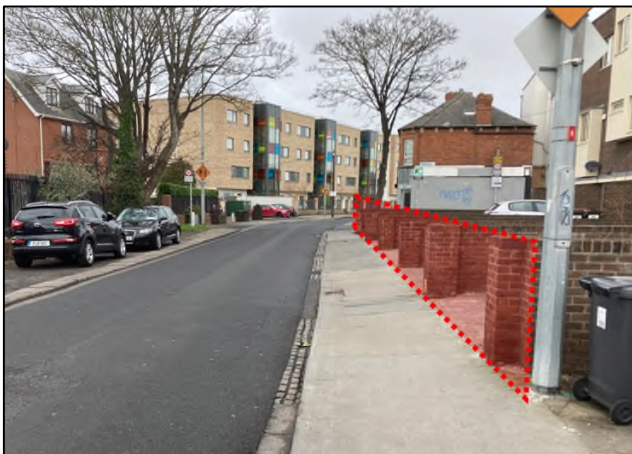
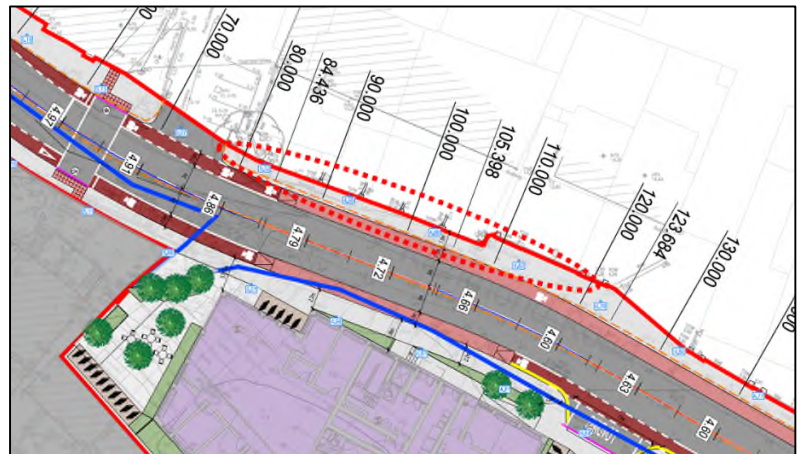
**Problem S7 – Vehicular accesses to houses.**

It is unclear to the auditors what kerb heights are proposed for the cycle track and pedestrian route adjacent to the vehicular accesses to houses along Richmond Road. Failure to provide suitable kerb heights/access to the houses may result in material damage to vehicles or damage to the pedestrian or cycle facilities which may result in trips or falls.

**Recommendation:**

The design team should clarify the cross section/detail for the pedestrian and cycle route adjacent to the houses access on Richmond Road. Suitable transitions/kerb heights should be provided.

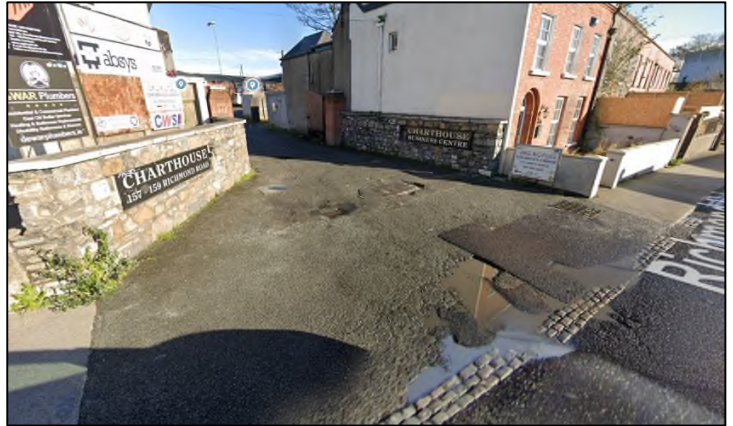
**Problem S8 – Vehicular accesses to Charthouse Business Centre.**

During the site visit, the auditors noted an HGV exiting the Charthouse Business Centre. It is unclear to the auditors the kerb heights proposed for the cycle track and pedestrian route adjacent to the vehicular access to Charthouse Business Centre. Failure to provide a suitable access treatment may result in material damage to vehicles or damage to the pedestrian or cycle facilities which may result in trips or falls.

**Recommendation:**

The design team should clarify the access treatment proposed at the Charthouse Business Centre. Suitable transitions/kerb heights should be provided.

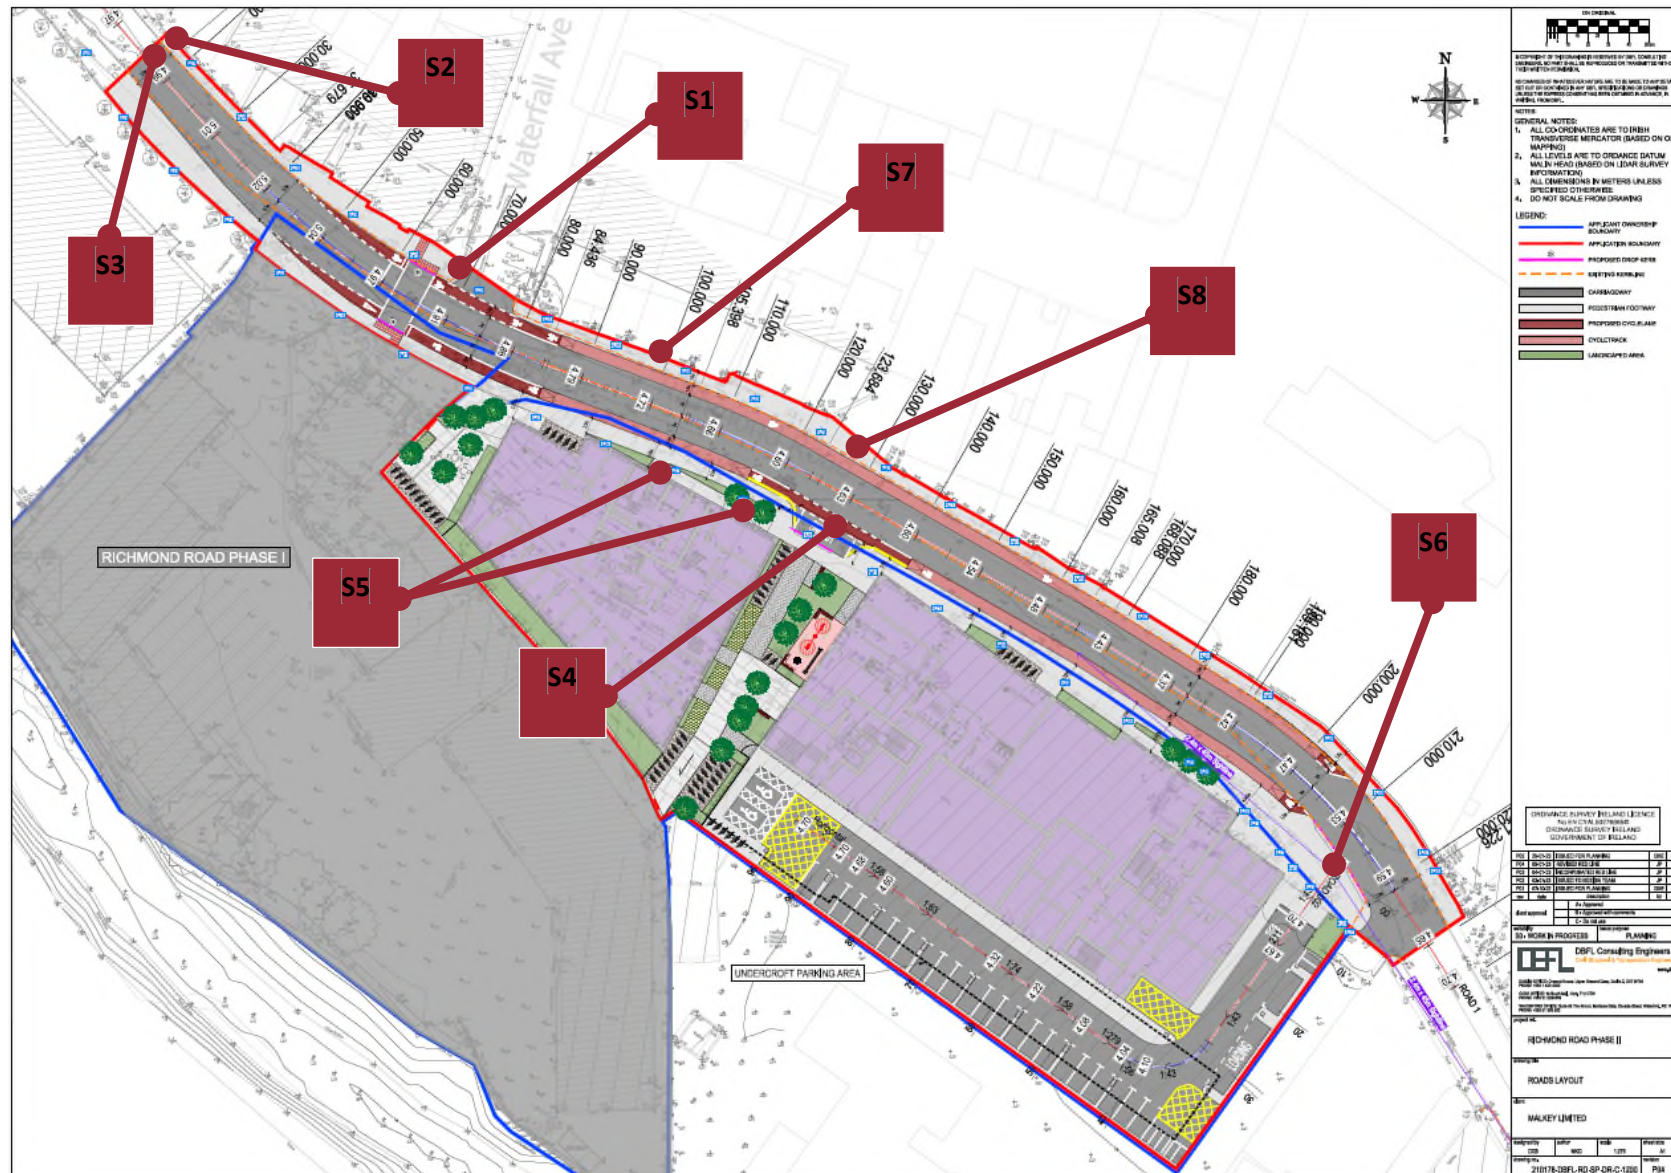
### Problem Location Plan.

A plan drawing showing the problem locations is contained in **Appendix C**.
